Rimkus Consulting Group, Inc.
Eight Greenway Plaza, Suite 500
Houston, TX 77046
(800) 580-3228 Telephone
(713) 623-4357 Facsimile

Re: RCG File No: 11009971
LLV Number: 0209452
VMF Location: 1530 Greensmark Drive in Houston, Texas
Subject: Final Report

Rimkus Consulting Group, Inc. was retained to examine LLV 0209452, VIN 1GBCS10E4M2908832. The fire occurred on June 13, 2016 at around 12:30 P.M. the operator of the vehicle at the time of the fire, was unavailable for interview but reportedly stated the vehicle's engine died while delivering mail on his route and backfired during subsequent attempts to restart it. Soon thereafter, smoke was observed from beneath the hood as well as flames.

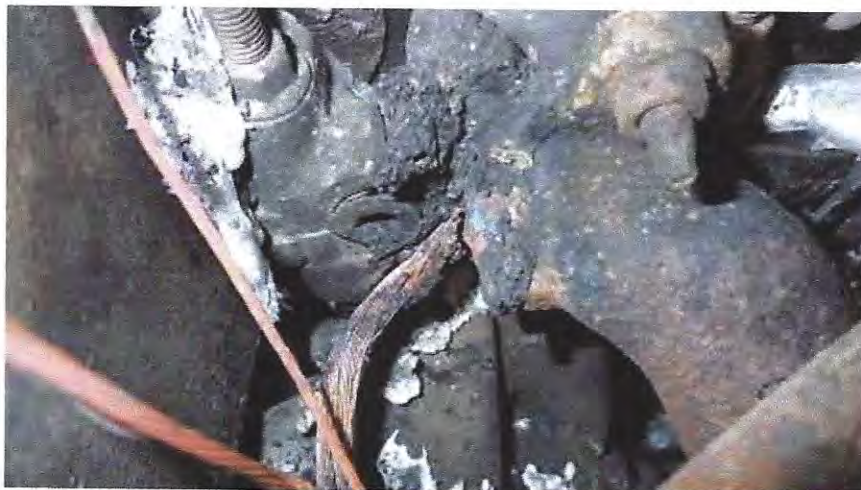
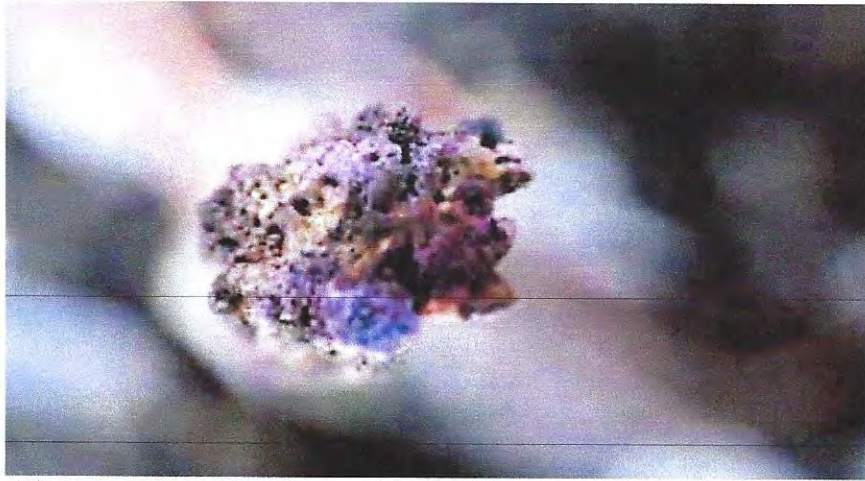
After a complete examination of this vehicle, the point of origin was determined to be the battery cable coming in contact with the manifold on the left side of the engine. The probable cause of this contact would be improper routing of the cable during maintenance.

1. The area of origin is the left side of the engine.
2. The point of origin is the battery cable at the top of the manifold.
3. The contact of the battery cable with the manifold melted away the insulation allowing the exposed wire to contact the manifold and produce electrical arcing.
4. This arcing continued until the cable severed and the vehicle stalled.

View of opposite side of battery cable fused to manifold.

Close up view of battery cable that had been fused to manifold.

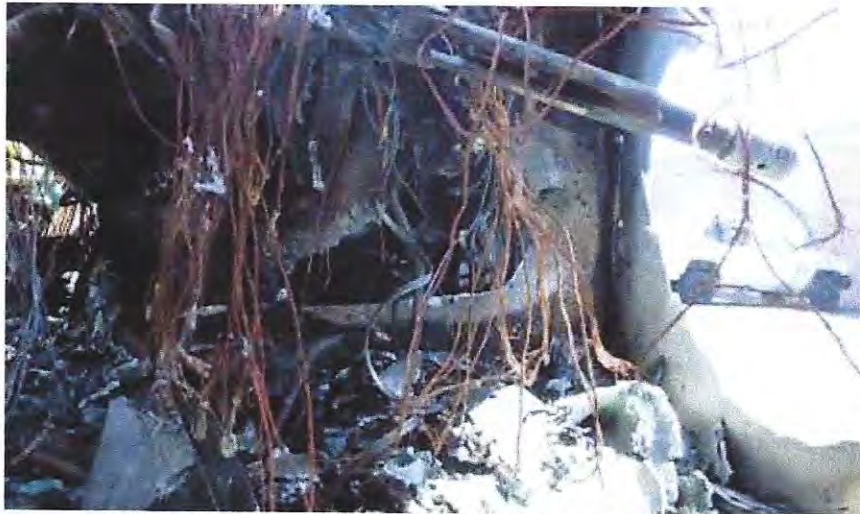
All the fire damage to this vehicle showed the fire originated at the fuse block. The fuse block and attached wiring had been consumed by fire. With the fire damage it will not be possible to determine the first failure, however, the fuse block and associated wiring was at the point of origin.

1. The origin of this fire is at the location of the fuse block.
2. The fuse block and associated wiring had been consumed by fire.
3. The first failure at the fuse block cannot be determined.
4. With the complete destruction of the fuse block and first failure not found. This fire must remain undetermined in nature.

View of fuse block location and damage to wiring.

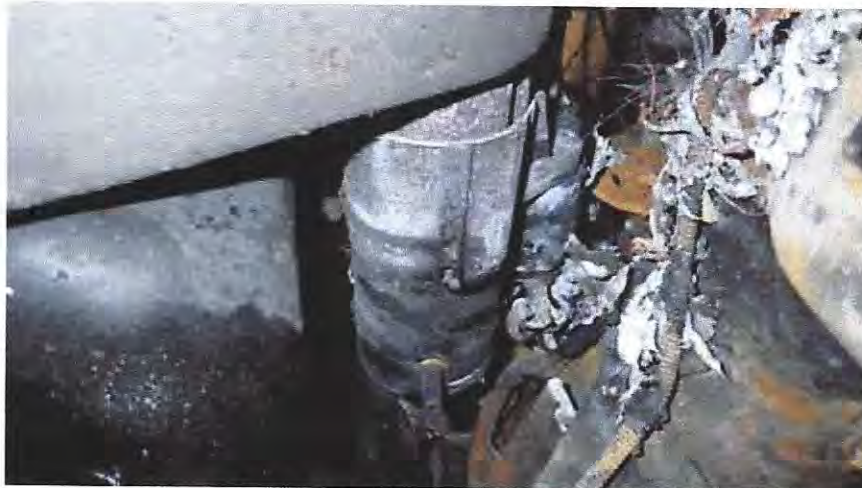
The examination of the fire damage revealed a fire occurred in the engine compartment. Due to the flammability of the engine fluids and available fuels, combined with an extended extinguishment time, the fire consumed all available combustibles.

A possible hypothesis for the cause of the fire may be the result of an electrical issue with the starter or related wiring. The fact that the carrier heard sparking noises and smelled an odor of electrical burning prior to the vehicle shutting down. This would indicate an electrical event occurring within the engine compartment. Also, when the vehicle was picked up and driven, flickering sparks were observed from under the vehicle, prior to the fire. When the fire occurred, the starter was damaged. Maintenance records indicated that the starter and engine were recently replaced. The above facts would support this scenario.

1. The area of origin for this fire was determined to be the engine compartment.
2. The point of origin could not be determined do to the lack of information and severe fire damage.
3. A possible hypothesis for the cause of the fire was noted in the above discussion section.
4. Because there is more than one possible hypothesis, the cause of the fire must be listed as undetermined.

View of undercarriage and starter damage.

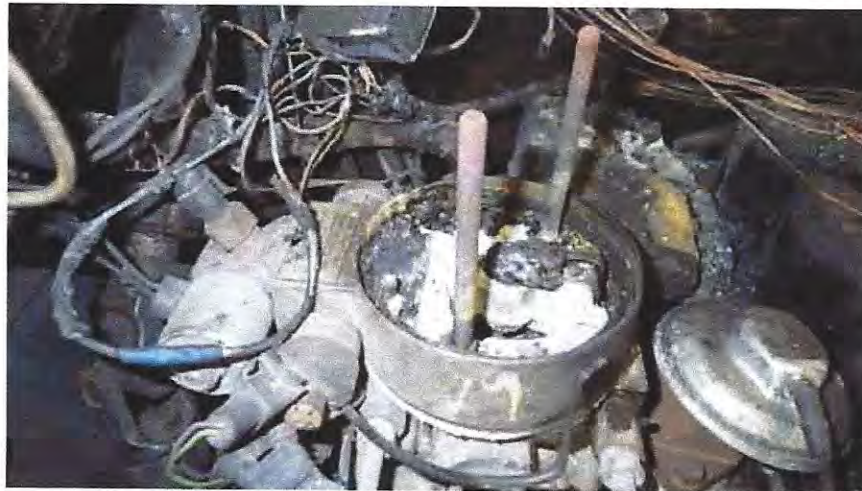
The examination of the fire damage revealed that a fire occurred in the engine compartment. The fire extended from the carburetor/CNG system and into the engine compartment. The carburetor had fuel in the injection system when a "back fire" occurred, igniting the unburned fuel causing a flame. The fire damaged nearby combustibles, wire loom, wiring, and some plastics, along with fire damage to the hood and cowl areas.

1. The area of origin for this fire was determined to be the engine compartment.
2. The point of origin was determined to be the carburetor.
3. The failure of the engine to run properly caused a back fire, which produced a flame that ignited nearby fuel.
4. After a complete investigation of this fire loss, Trident has determined this fire to be a mechanical failure.

View of point of origin.

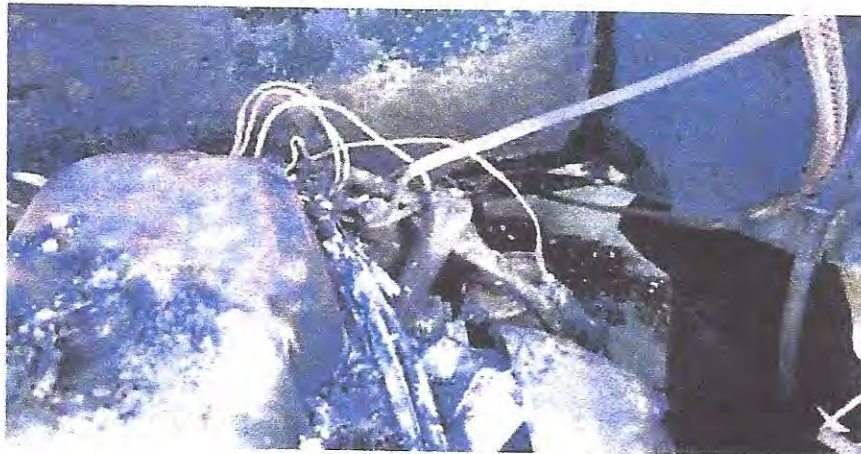
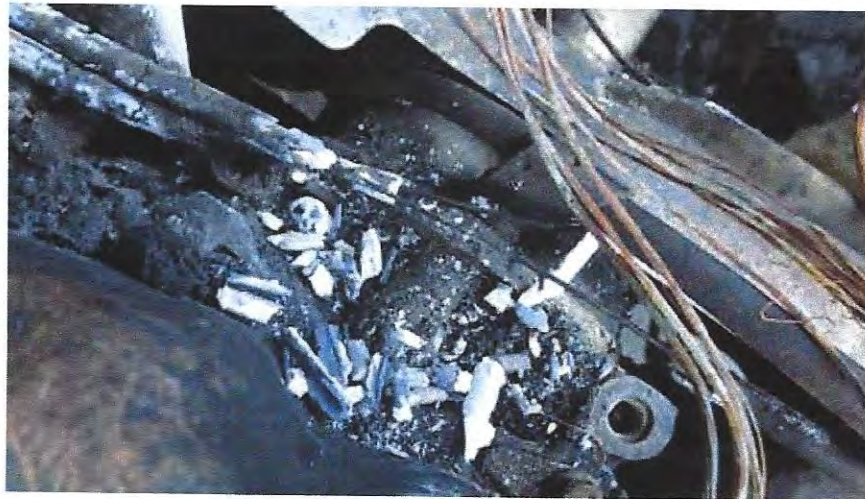
The origin for this fire is determined to be at the top of the engine at the rear two plug wires. The first fuel ignited would have been the available combustible fluids in this area. With the destruction of the plug wires, no evidence of arc or spark was noted. It is a probable hypothesis that a failure of one or both of these plug wires ignited available combustibles on the engine. This failure would also explain [REDACTED] report that it seemed the vehicle shut down prior to him turning the key to the off position. It should also be noted that the replacement three times within a year of the spark plugs and no replacement of the plug wires, an ongoing minor failure of the plug wires may have caused damage to the spark plugs.

1. The area of origin is the top of the engine at the rear.
2. The point of origin is determined to be at the location of the plug wires in this area.
3. With the destruction of the plug wires, no evidence of failure could be found, causing this fire to remain undetermined in nature.

Point of origin.

Plug wire damage.

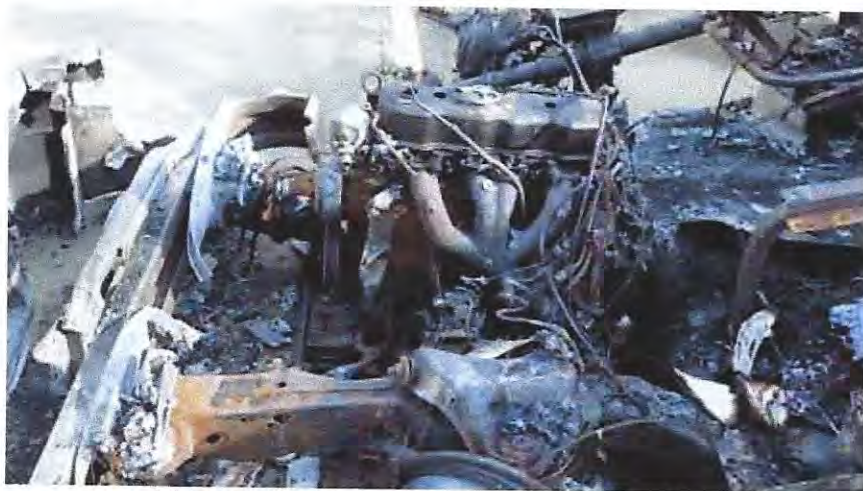
The examination of the fire damage revealed a fire occurred in the engine compartment. Due to the flammability/combustibility of the engine fluids and available fuels, combined with an extended extinguishment time, the fire consumed all available combustibles in this area and extended to the passenger and cargo compartments.

A possible hypothesis for the cause of the fire may be the result of a hot surface ignition. The fact that the fuel filter supply line was found loose, combined with fire patterns would indicate a gasoline leak. Also the information from the VMF, which the fuel filters connections are vibrating loose, would further corroborate the above facts. The LLV was also serviced 7 days prior to the fire.

A fuel leak with the filter mounted to the engine would spray gasoline on to the hot exhaust manifold.

1. The area of origin for this fire was determined to be the engine compartment.
2. The point of origin could not be determined do to the lack of information and the severe fire damage.
3. A possible hypothesis for the cause of the fire was noted in the above discussion section.
4. Because there is more than one possible hypothesis, the cause of the fire must be listed as undetermined.

View of the engine compartment damage.

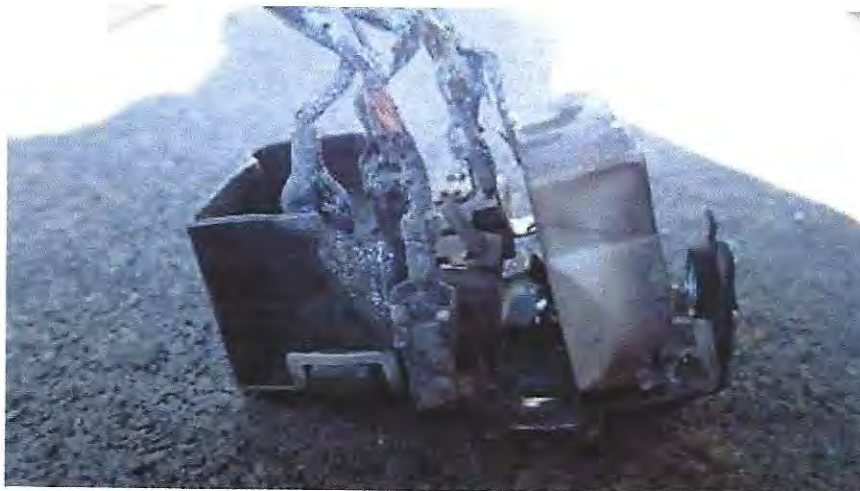
The examination of the fire damage revealed a fire occurred in the passenger's compartment. The headlight switch was also found severely damaged. The headlight switch failed, causing an over current. This failure was caused by excessive current, causing heat to ignite the plastic housing and wire insulation.

1. The area of origin for this fire was determined to be the passenger's compartment, specifically the dash area on the interior.
2. The point of origin was determined to be the headlight switch.
3. The failure of the headlight switch caused it to produce an over current/excessive heat situation.
4. After a complete investigation of this fire loss, Trident has determined this fire to be a mechanical failure.

View of the headlight switch point of origin.

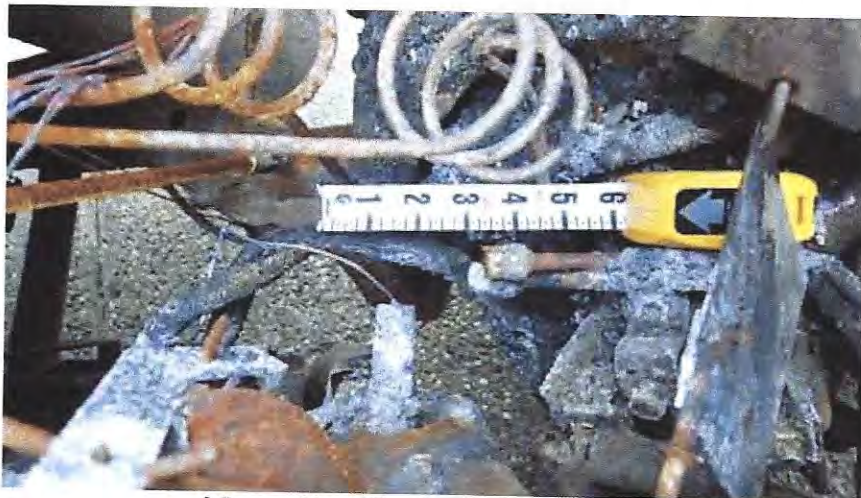
After a complete examination of all fire damage and patterns, Trident has concluded that this fire originated at the fuel line leading from the throttle body. This line had no record of replacement. With the damage to the fuel line, Trident cannot conclude if the line placement was involved (e.g. too close to manifold or a failure of the line occurred).

1. The area of origin for this fire is the left side of the engine compartment.
2. The point of origin is determined to be the fuel line leading from the throttle body.
3. The carrier reported he smelled gasoline then attempted to start the vehicle.
4. Trident cannot determine if there was a failure of the fuel line, due to being too close to the manifold, or if the line failed due to age and wear.

View of length of missing fuel line.

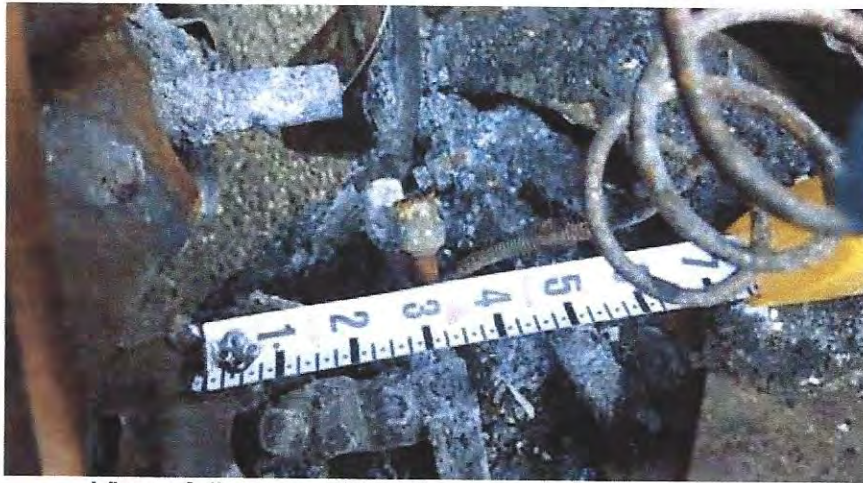
View of distance of fuel line connection to manifold.

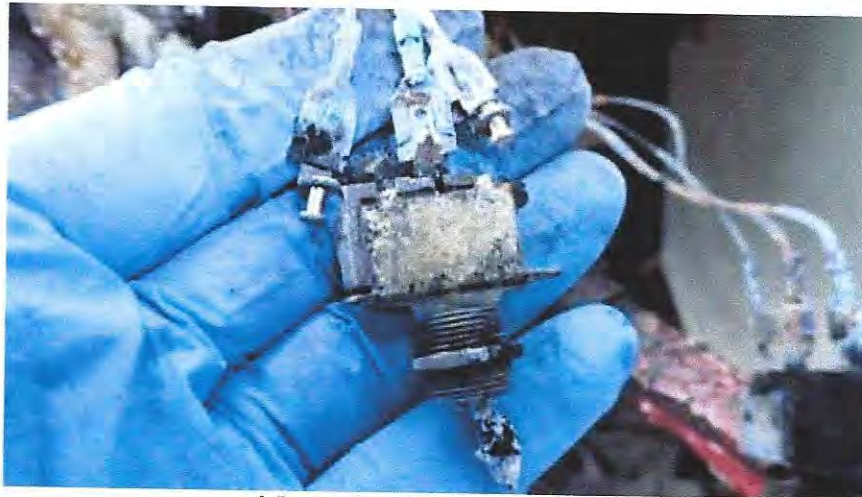
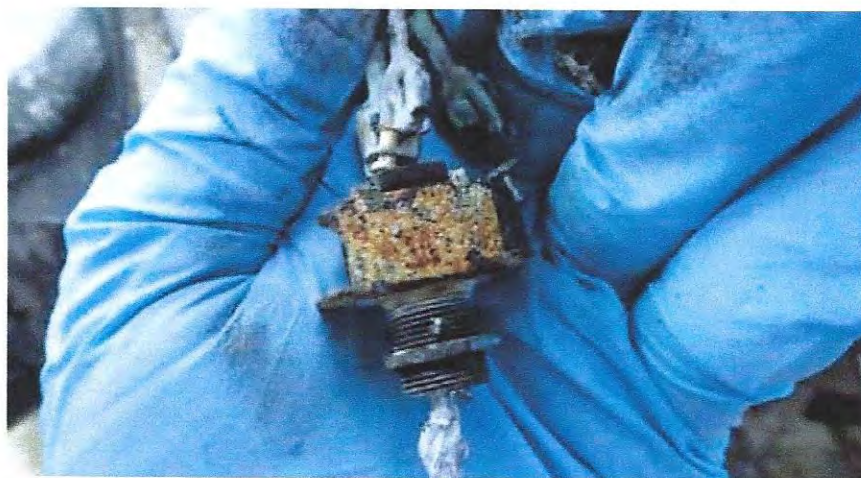
After a complete investigation into this fire loss, Trident has concluded that the fire originated at the toggle switch for the cargo light. This switch is located on the right side of the dash, above the emergency brake. The exact failure of this switch cannot be determined due to the extensive damage to the switch. Examination of the available maintenance records do not show any replacement of this switch either recent or past. This failure is probably due to the age and use of the switch.

1. The area of origin is the right side of the dash.
2. The point of origin is determined to be at the cargo light toggle switch.
3. The cause of this fire is determined to be a failure of the cargo light switch.

View of cargo light switch.

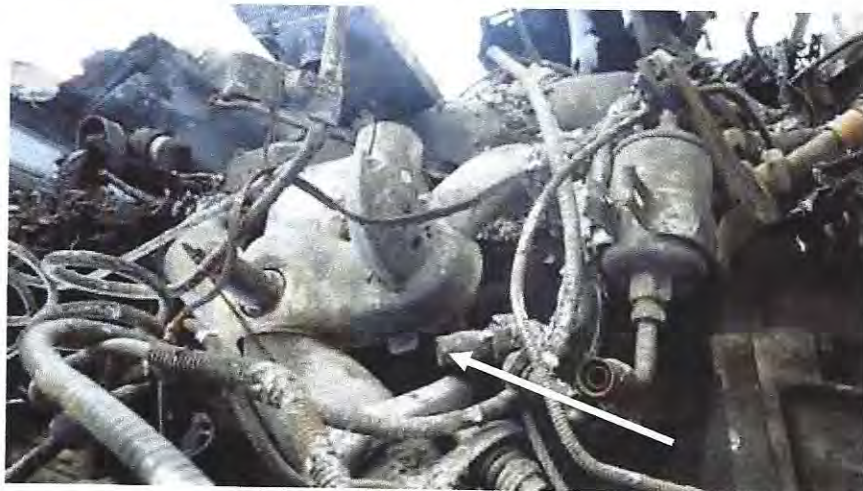
The examination of the fire damage revealed a fire occurred in the engine compartment. The fire extended from the exhaust manifold and into the engine and passenger compartments. Witness accounts report seeing dripping flames on the left side of the LLV as it was being driven. Shortly after the LLV stopped, it burst into flames. The pressurized rubber fuel line was mounted less than 1 inch from the heated exhaust manifold. This would cause damage to the line and cause it to spray/atomized gasoline over the heated exhaust manifold, causing a hot surface ignition, and creating the fire.

1. The area of origin for this fire was determined to be the engine compartment.
2. The point of origin was determined to be the exhaust manifold.
3. A leak from the return fuel line caused gasoline to spray onto the hot exhaust manifold.
4. The gasoline sprayed onto the heated exhaust manifold causing a hot surface ignition and igniting available combustibles.
5. The return fuel line was mounted too close to a heat source.

View of the point of origin.

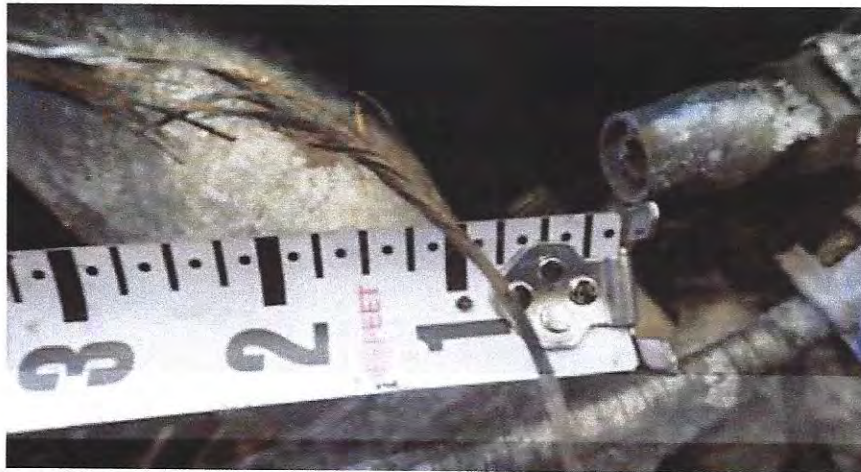
View of the point of origin showing fuel line distance from heat source.

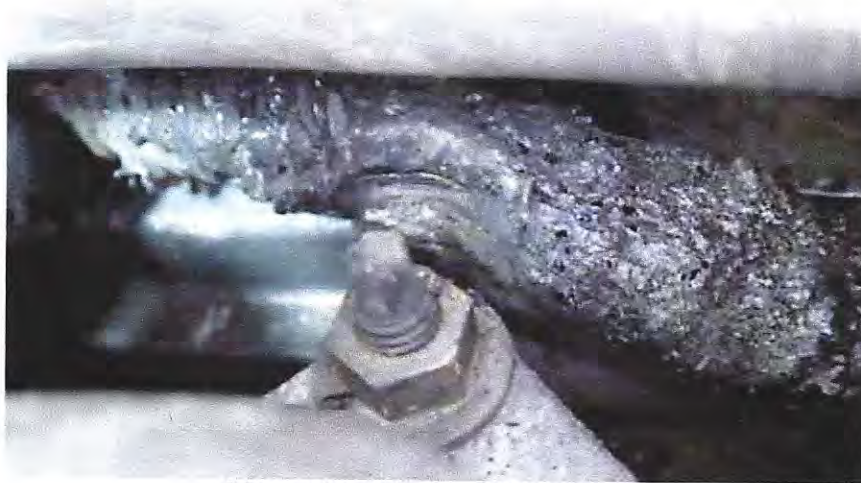
1. The area of origin for this fire was determined to be the engine compartment.
2. The point of origin was identified as the positive battery cable near the starter.
3. The positive cable was in direct contact with the metal motor mount.
4. There is evidence of an arc occurring at the motor mount causing the cable insulation and wire loom to ignite the available combustibles.
5. After a complete investigation of this fire loss, Trident has determined this fire to be a mechanical failure.

View of positive cable pinched.

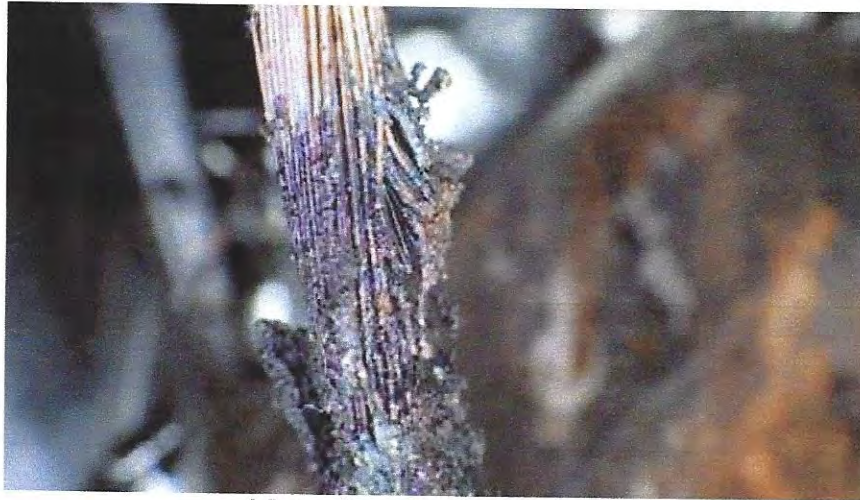
View of positive cable fault.

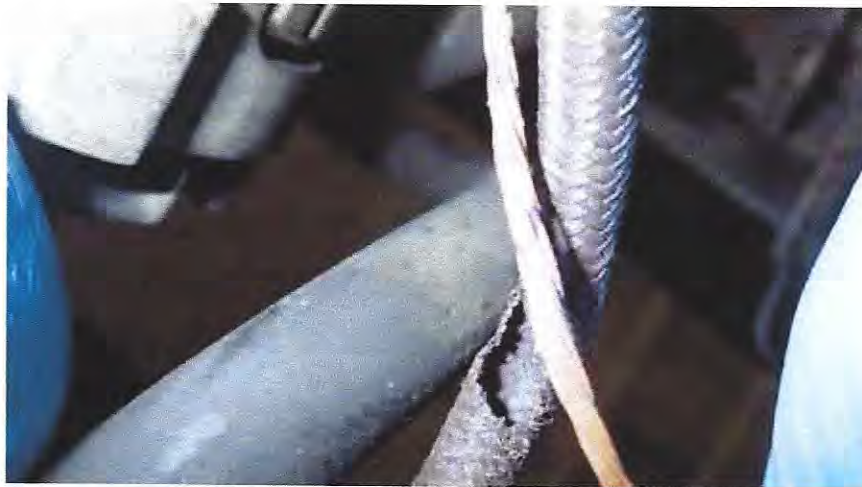
The examination of the fire damage revealed a fire occurred in the engine compartment. The fire was contained to the engine compartment, specifically to the right side. Witness accounts report seeing dripping flames from under the engine of the LLV. The transmission coolant line was lying on top of the wire from the alternator to the positive battery terminal. The wire was tight, due to the weight of the hose and fluid.

This caused friction, causing damage to the line and spray transmission fluid over the heated wire, causing an arc igniting the fluid and insulation.

1. The area of origin for this fire was determined to be the engine compartment.
2. The point of origin was determined to be the positive battery wire.
3. A leak from the transmission coolant line caused transmission fluid to spray onto the heated wire.
4. The transmission fluid sprayed onto the heated wire, causing it to arc and ignite available combustibles.
5. After a complete investigation of this fire loss, Trident has determined this fire to be a mechanical failure.

View of hole in transmission line.

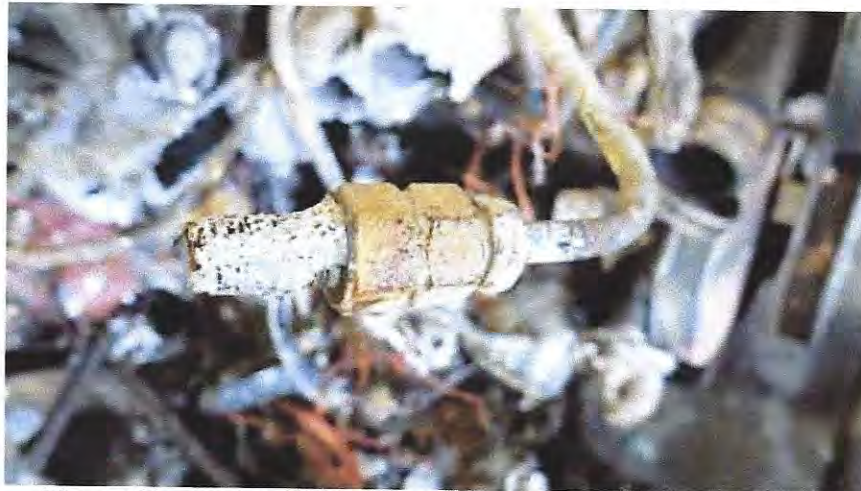
The most probable cause of this fire is a failure of the female connector for the return fuel line. This failure would explain the evidence of smoke during acceleration and braking as these two points would be when the most fuel is being transferred through the return line. With no evidence of replacement of the throttle body, it is possible that this is original equipment had exceeded its life span.

1. Trident has determined the area of origin for this fire to be the top right side of the engine.
2. Trident has also concluded that the point of origin is the right side of the throttle body.
3. With the information gathered, the probable cause is a failure of the female connection, attached to the throttle.
4. The location of the point of origin leaves the exact source of ignition undetermined. However, the probable source is the fuel from the return line igniting on the hot surface of the engine.
5. The continued operation of this vehicle after an operational problem noted, contributed to the ignition.

View of fuel return line that was connected to throttle body.

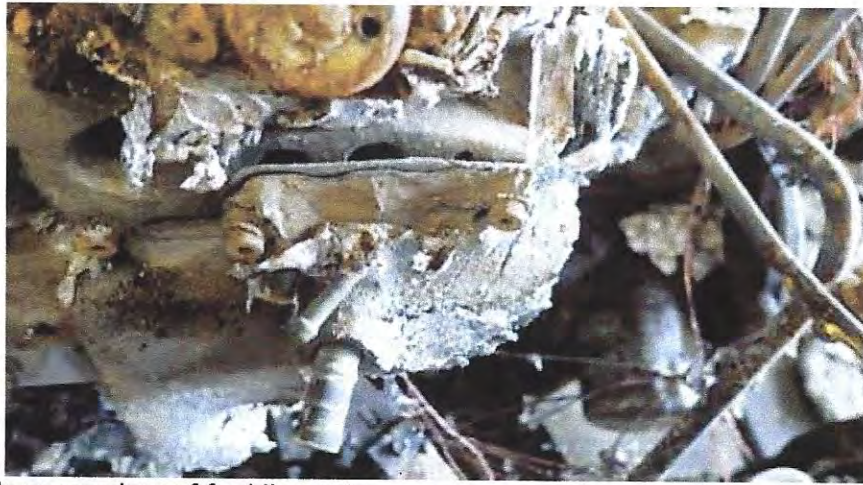
Close-up view of fuel line return area connection showing separation.

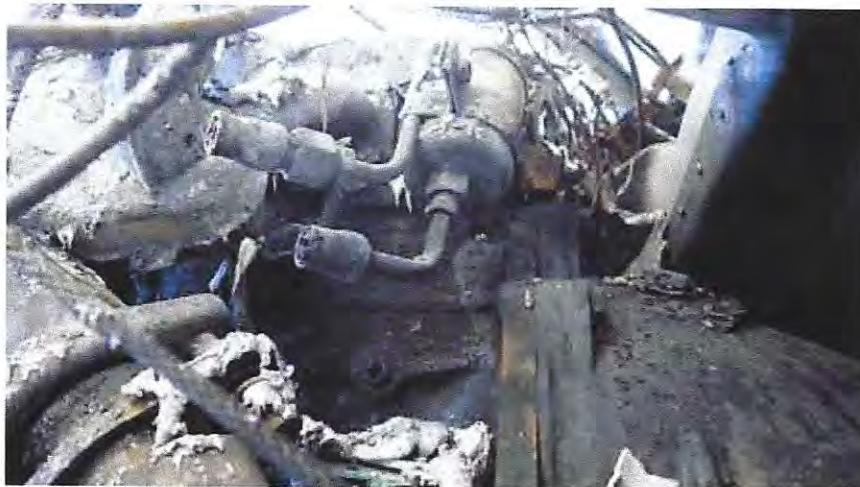
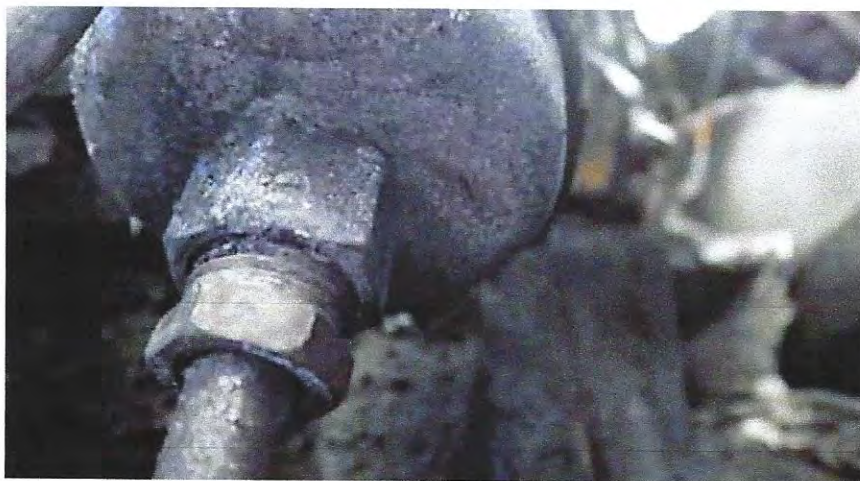
The examination of the fire damage revealed a fire occurred in the engine compartment. The fire extended from the exhaust manifold and into the engine and passenger compartments. Witness accounts reported seeing fluid on roadway and a vehicle smoking. After a short period of time, they observed flames on left side of the LLV. The fuel filter with a loose supply line would spray atomized gasoline over the heated exhaust manifold, causing a hot surface ignition and creating the fire.

1. The area of origin for this fire was determined to be the engine compartment.
2. The point of origin was determined to be the exhaust manifold.
3. A leak from the fuel filter supply line caused gasoline to spray onto the hot exhaust manifold.
4. The gasoline sprayed onto the heated exhaust manifold caused a hot surface ignition and ignited available combustibles.
5. After a complete investigation of this fire loss, Trident has determined this fire to be a mechanical failure.

View of the point of origin.

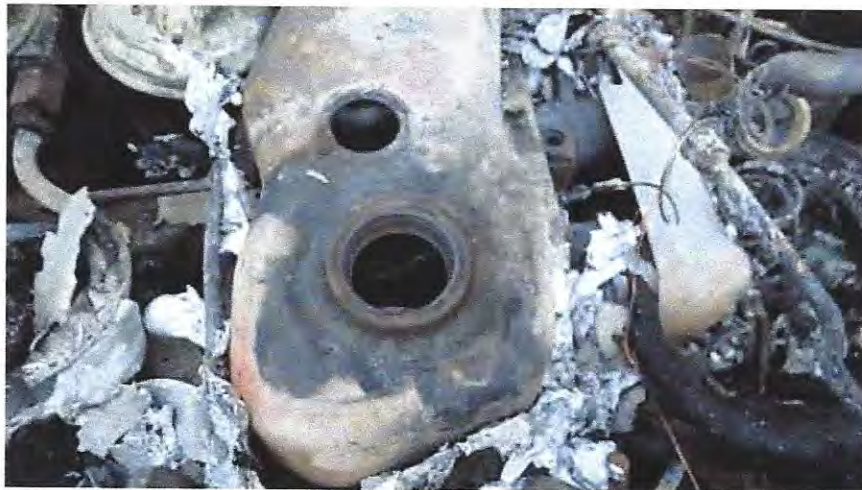
After evaluation of all information available Trident has concluded that the involved vehicle was being operated in a mechanically unreliable condition at the time of the fire. Trident determined through operator interview the vehicle was not operating properly at the time of initial startup and the vehicle was continually operated until the fire occurred.

1. Trident concluded that the most probable cause for this fire is that the oil fill cap was not in place at the time of operation.
2. This would have caused the oil to be expelled out through the opening and to have ignited on the hot surface of the exhaust manifold and engine itself.
3. This would also explain the lifter tapping sound due to low oil pressure from oil fill cap not being in place.

View showing oil fill cap.

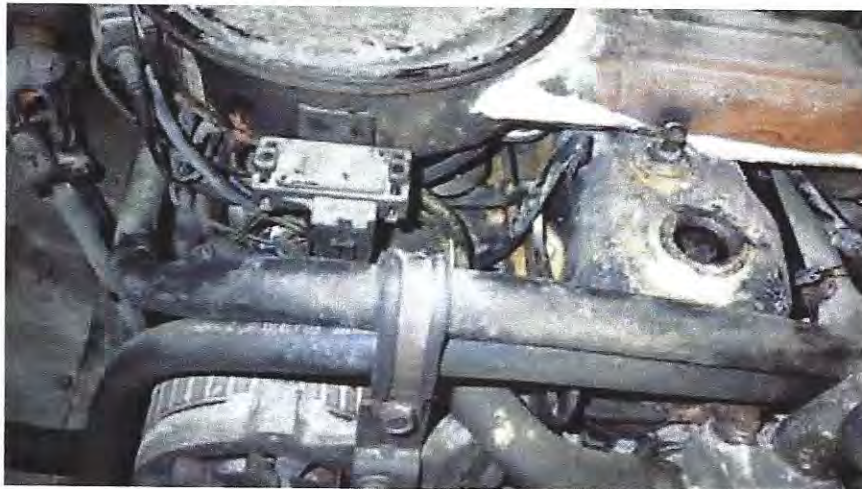
The examination of the fire damage revealed a fire occurred in the engine compartment. The fire extended from the exhaust manifold to the valve cover area. The fire was contained to the engine compartment area. Witness accounts reported seeing no oil filler cap and a bottle of oil sitting on the engine, prior to the fire. When the vehicle was driven back to the branch, where it stalled out, it began smoking. After a short period of time, flames were observed on left side of the LLV. The oil leaking over the heated exhaust manifold caused a hot surface ignition, creating the fire.

1. The area of origin for this fire was determined to be the engine compartment.
2. The point of origin was determined to be the exhaust manifold.
3. There was no oil filler cap, and there was a bottle of oil sitting on the hot exhaust manifold.
4. The oil leaking onto the heated exhaust manifold caused a hot surface ignition and the ignition of available combustibles.
5. After a complete investigation of this fire loss, Trident has determined this fire to be a mechanical failure.

View of the point of origin.

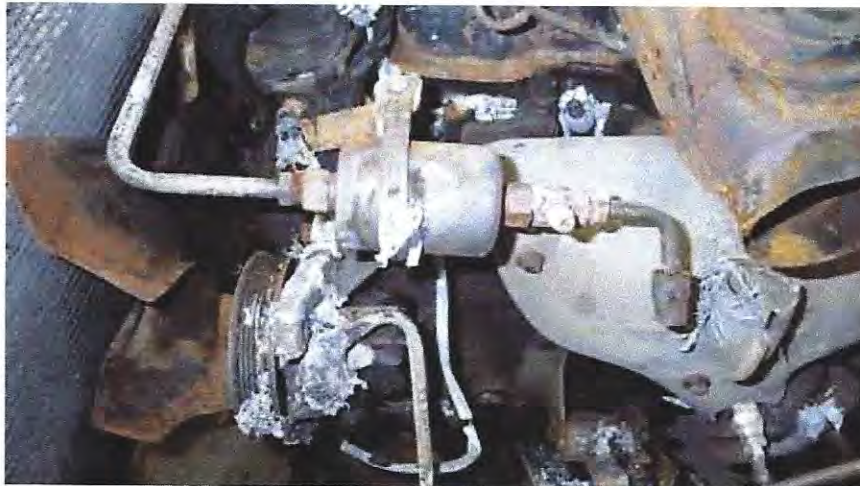
With the observations of improper mounting of the fuel line, fuel filter and fuel filter connections, Trident concludes that this fire was caused by a fuel leak from either the fuel filter connections or unsecured fuel lines.

1. The origin of this fire is the left side of the engine.
2. The gas from the fuel filter and or associated lines coming in contact with the heated exhaust manifold is the first fuel ignited.
3. This gas leak being the result of the fuel filter and or associated fuel line installation problems is the cause of this fire.
4. The point of first failure cannot be determined due to multiple installation problems determined with the fuel filter and associated lines.

View of fuel filter mounting.

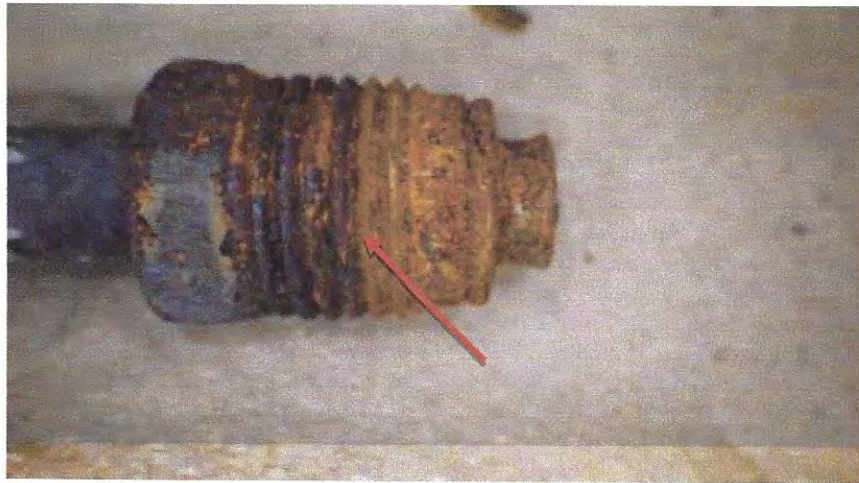
View of where threads were located in connection.

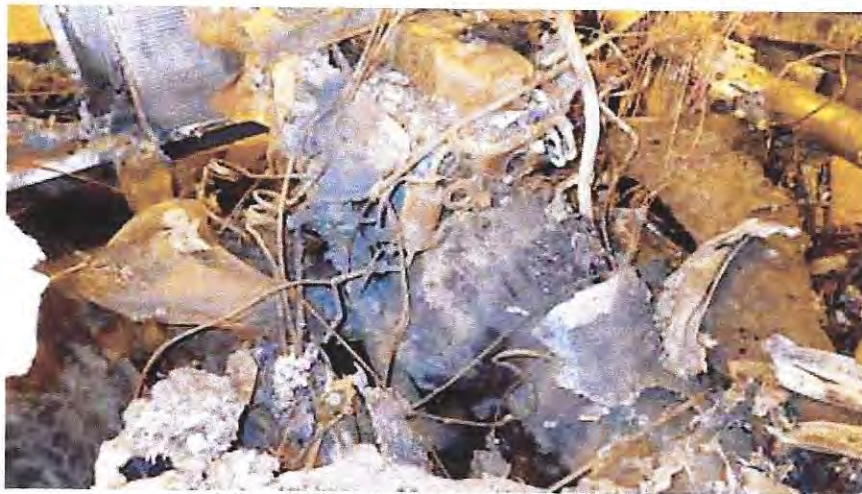
The examination of the fire damage revealed a fire occurred in the engine compartment. Due to the flammability/combustibility of the engine fluids and available fuels, combined with an extended extinguishment time, the fire consumed all available combustibles in this area and extended to the passenger and cargo compartments.

A possible hypothesis for the cause of the fire may be the result of a hot surface ignition. The fact that the fuel filter supply line was found loose, combined with fire patterns would indicate a gasoline leak. Also information from the VMF, which revealed that the fuel filters connections are vibrating loose, would further corroborate the above facts. The LLV was also serviced 7 days prior to the fire and a loose fuel line was not documented.

1. The area of origin for this fire was determined to be the engine compartment.
2. The point of origin could not be determined do to the lack of information and the severe fire damage.
3. A possible hypothesis for the cause of the fire was noted in the above discussion section.
4. Because there is more than one possible hypothesis, the cause of the fire must be listed as undetermined.

View of the left side fire damage.

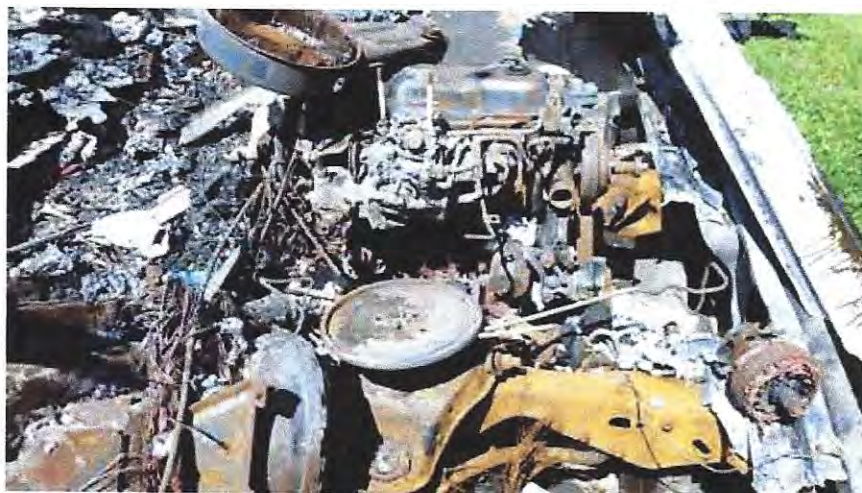
After a complete investigation of this fire loss, Trident is unable to determine the first failure, leading to this fire loss. The carrier reported black smoke from the vehicle when 911 was notified and a 911 response time of several minutes. The damage to the components within the engine compartment indicated a long duration fire.

1. Noted fire damage revealed the area of origin to be the right side of the engine.
2. With the complete consumption of components by fire within the area of origin, a determination of the first failure will not be possible.
3. The extensive damage by fire of the components within the engine compartment indicates a long term exposure to fire. This long term exposure to fire contradicts the carrier time frame of 911 notification and arrival.

View of right side of engine with air cleaner removed.

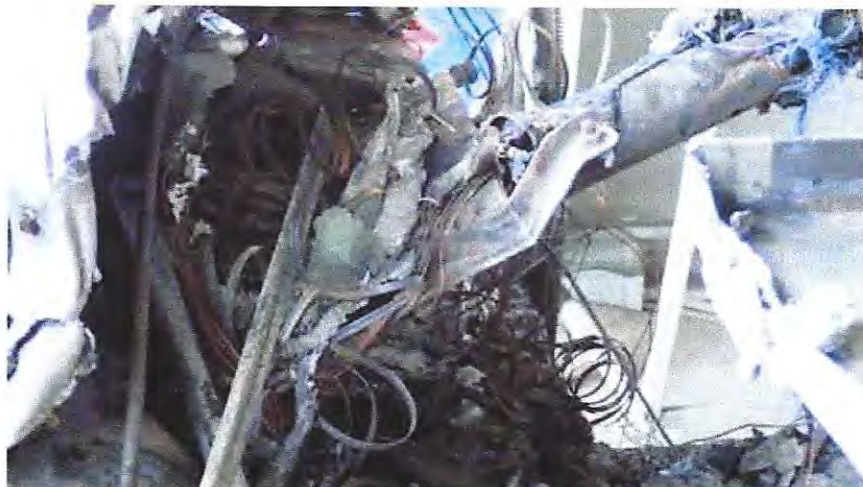
With the examination of the wire harness revealing no evidence of failure, Trident determined the first failure to involve associated components within the dash at the area of the steering column. With the complete destruction of the dash area and associated components Trident was unable to determine the first failure in this area.

1. The area of origin for this fire was in the dash area above the steering column.
2. The exact point of origin could not be determined due to the extent of fire damage in the area of the vehicle's dash.
3. Trident concluded that the new wiring harness had not been involved in the ignition of this fire
4. Trident has classified this fire as undetermined in nature.

Close up view of dash area at steering column.

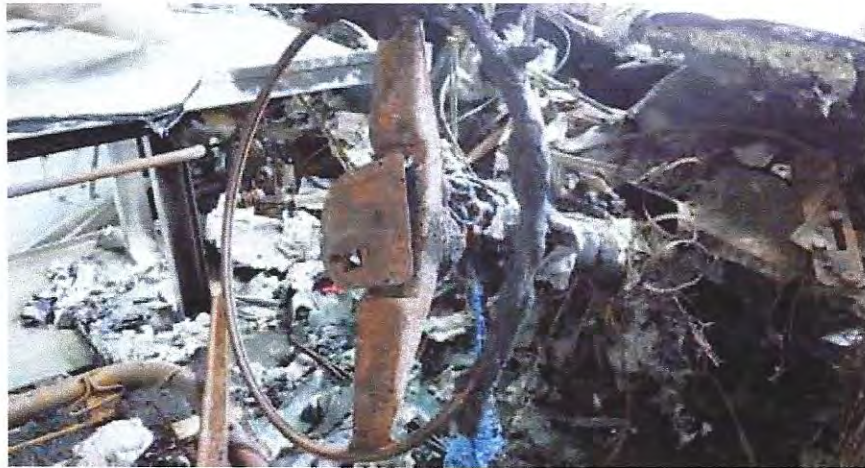
Alternate view of dash area.

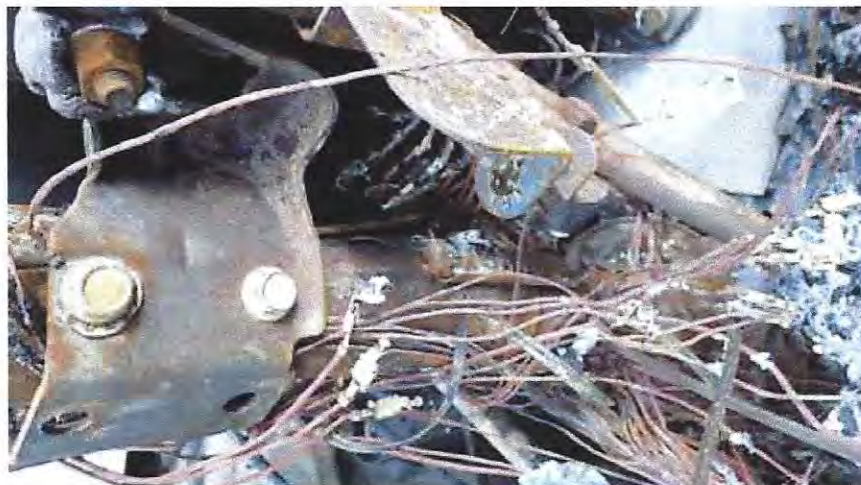
The examination of the fire damage revealed a fire occurred in the passenger compartment which extended to the engine compartment causing extensive damage. The main engine wiring harness was partially consumed by direct fire attack. The ignition interrupter located on the lower half of the steering column was consumed by fire.

A possible hypothesis for the cause of the fire may be the result of an electrical failure. This is based upon the ignition interrupter along with missing wire from the main engine wiring harness, along with the witness smelling an odor of electrical wires burning while driving the LLV.

1. The area of origin for this fire was determined to be the passenger compartment.
2. The point of origin could not be determined due to the lack of information and extensive fire damage.
3. A possible hypothesis for the cause of the fire was noted in the above discussion section.
4. Because there is more than one possible hypothesis, the cause of the fire must be listed as undetermined.

View of the area of origin.

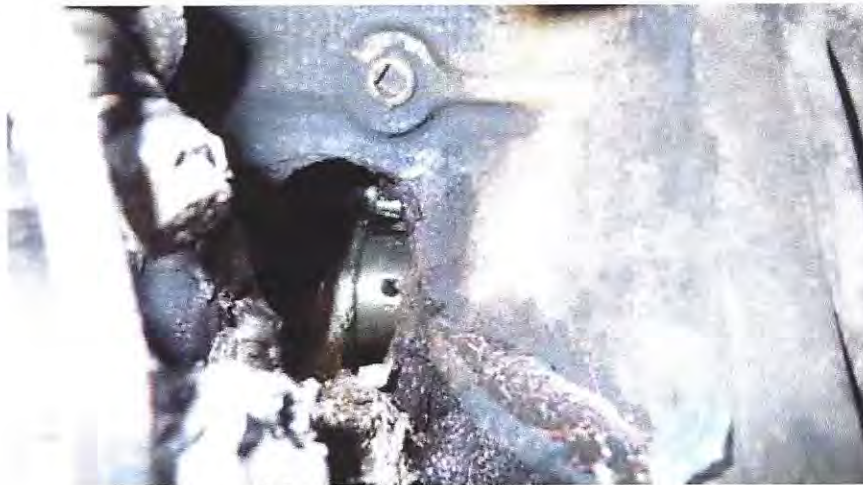
The examination of the fire damage revealed a fire occurred in the engine compartment. The fire extended from the exhaust manifold and into the engine and passenger compartments. Witness accounts reported hearing loud knocking noise from the engine which got worse until the engine made a loud bang. After a short period smoke and fire was observed from the hood of the LLV. The engine failed due to a lack of oil and threw a rod through the block. This caused the leftover oil to leak onto the heated exhaust manifold causing a hot surface ignition and creating the fire.

1. The area of origin for this fire was determined to be the engine compartment.
2. The point of origin was determined to be the exhaust manifold.
3. The engine failed causing a hole in the block which allowed oil to leak onto the hot exhaust manifold.
4. The oil leaking onto the heated exhaust manifold caused a hot surface ignition and ignition of available combustibles.
5. After a complete investigation of this fire loss, Trident has determined this fire to be a mechanical failure.

View of the point of origin.

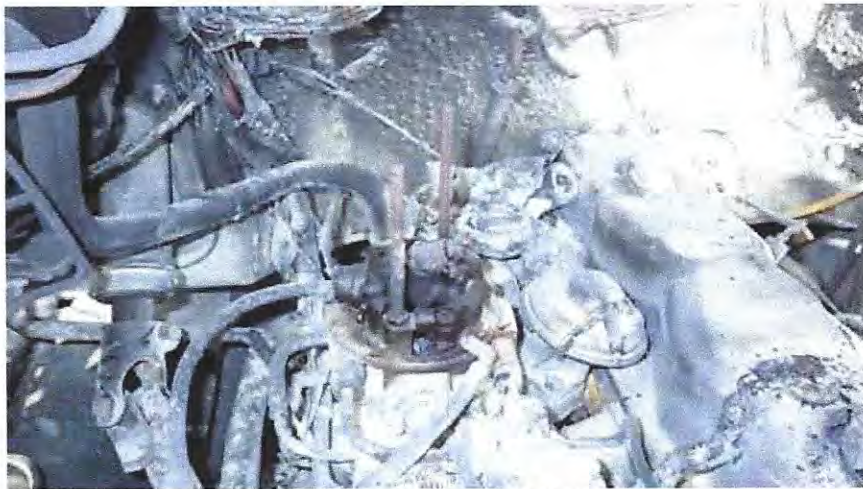
The examination of the fire damage revealed a fire occurred in the engine compartment. The fire extended from the carburetor/throttle body and into the engine compartment. The carburetor had fuel moving through the system when the "back fire" occurred, igniting the unburned fuel, causing a flame. The fire damaged nearby combustibles and wiring.

1. The area of origin for this fire was determined to be the engine compartment.
2. The point of origin was determined to be the carburetor/throttle body.
3. The failure of the engine to run properly caused a back fire, which produced a flame that ignited nearby fuel. The flame extended out of the air cleaner to ignite nearby combustibles through the gap in the air cleaner cover.
4. After a complete investigation of this fire loss, Trident has determined this fire to be a mechanical failure.

View of the point of origin.

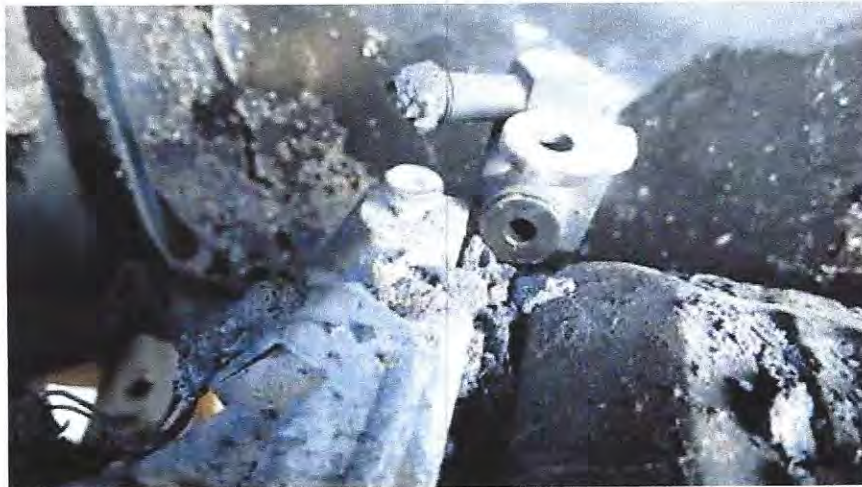
The examination of the fire damage revealed a fire occurred in the engine compartment. The fire extended from the fuel rail/manifold and throughout the engine compartment. The disconnected fuel line at the fuel rail leaked fuel over the heated manifold. The fire damaged nearby combustibles and wiring.

1. The area of origin for this fire was determined to be the engine compartment.
2. The point of origin was determined to be the fuel line connection.
3. The fuel line connection which came disconnected from the fuel rail system caused gas to leak on to the heated manifold. The fuel was ignited which produced a flame that ignited nearby combustibles. The flame extended from this area to ignite nearby combustibles.
4. After a complete investigation of this fire loss, Trident has determined this fire to be a mechanical failure.

View of the fuel line connection.

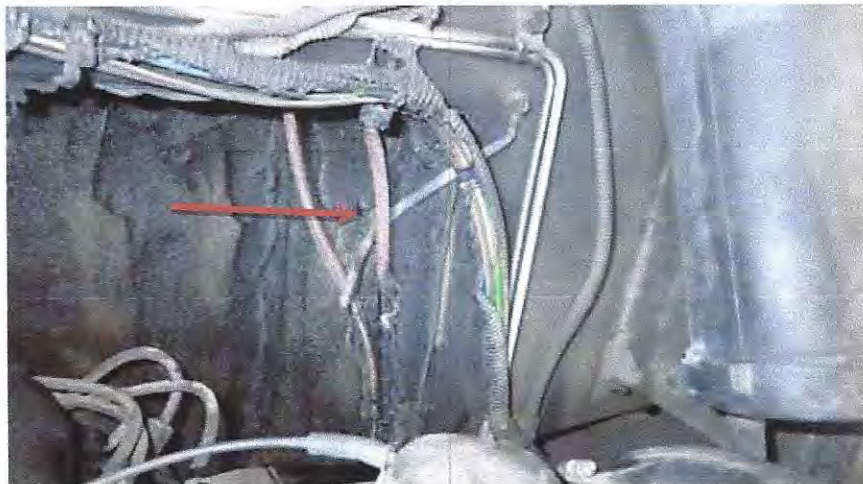
Trident's examination of the fire event occurring in LLV, No. 9211688 has concluded that two events came together to cause this fire. The first being an oil leak probably due to an overfill situation. The second being the ECM ground strap being secured behind the emergency brake cable causing the ground strap to fail. This failure would also explain the carrier reporting the vehicle starting but stalling out when placed in gear.

1. Trident has determined that the ignition source for this fire to have been the failure of the ECM ground strap due to it being secured behind the emergency brake cable.
2. This failure of the ground strap caused the failure of the ECM as well.
3. The failure of this ground strap would have caused electrical heating and arcing to occur that ignited the available oil being sprayed on it.

View of ground strap mounted behind emergency brake.

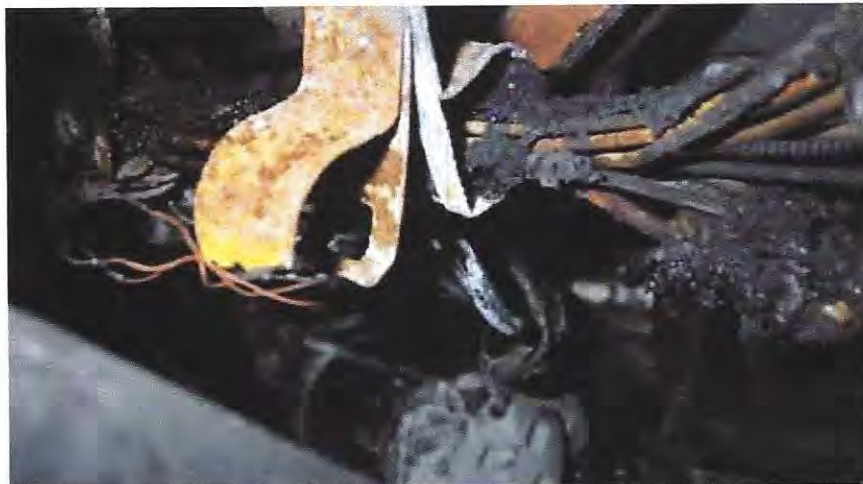
All fire damage and patterns examined indicate the fire to have originated at the mounting clamp for the positive and negative battery cables, located on the engine block. The damage to the wiring at this point indicates the most probable cause to be the metal clamp wearing away the insulation on the battery cable. The wearing away of the insulation would have exposed the uninsulated wire to contact the metal clamp and create a short circuit. This short circuit would have caused the vehicle to stall due to interrupted electrical power.

1. Trident has concluded that the area of origin for this fire to be the right side of the engine.
2. Trident has also concluded that the point of origin was at the mounting clamp that secured the positive and negative battery cables to the engine block.
3. The cause of this fire is determined to be electrical in nature with the battery clamp wearing away the insulation on the battery cable, causing a short circuit.

View of battery clamp.
